KIT CARSON HOUSE
Field Notes

KIT CARSON HOUSE & MUSEUM - RENOVATIONS
TAOS, NEW MEXICO

EXTERIOR ELEVATIONS - EXISTING
 KIT CARSON HOUSE & MUSEUM - CONDITION ASSESSMENT & PRESERVATION PLAN
 TAOS, NEW MEXICO

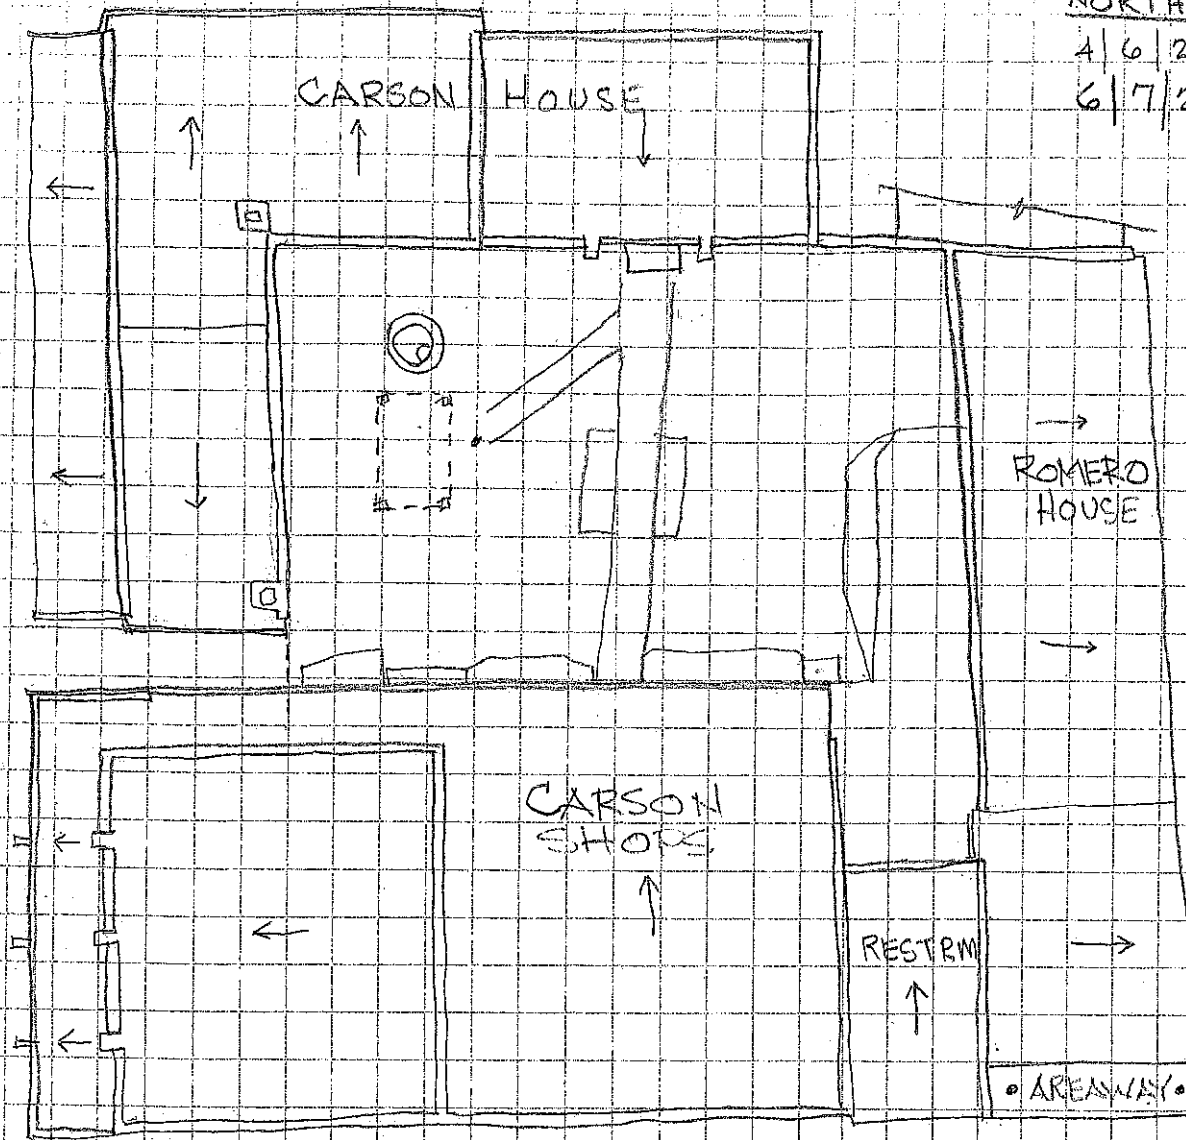
- SIGNIFICANT DRAINAGE ISSUES IN COURTYARD AND AROUND PERIMETER OF BLDG.
- EXT. FINISH GRADE ABOVE INT. FINISH FLOOR IN A NUMBER OF AREAS.
- CONSIDERABLE BASAL DETERIORATION. WATER NOT DRAINING AWAY FROM WALLS.
- CONTRA PARED ALONG NORTH SIDE OF ROMERO BLDG. IS TRAPPING WATER AGAINST WALL
- TREES AND OTHER VEGETATION AT OR NEAR BASE OF WALLS

- AREAWAY DRAINAGE IS PROBLEMATIC. 1990'S RESTROOM ADDITION BLOCKS DRAINAGE.
- MET ALEX ABEYTA AT SITE 6/7/22 TO REVIEW DRAINAGE AND PROPOSED WORK.
- SEE CHANGES IN ELEVATION SITE PLAN, 6/2/22 AND 6/7/22.
- REPORTED INLET DRAIN IN AREAWAY IS NOT VISIBLE.
- BRIEF CONVERSATION WITH JOE KENDALL, GENERAL MANAGER TAOS INN ABOUT POSSIBILITY OF REGRADING PARKING LOT.

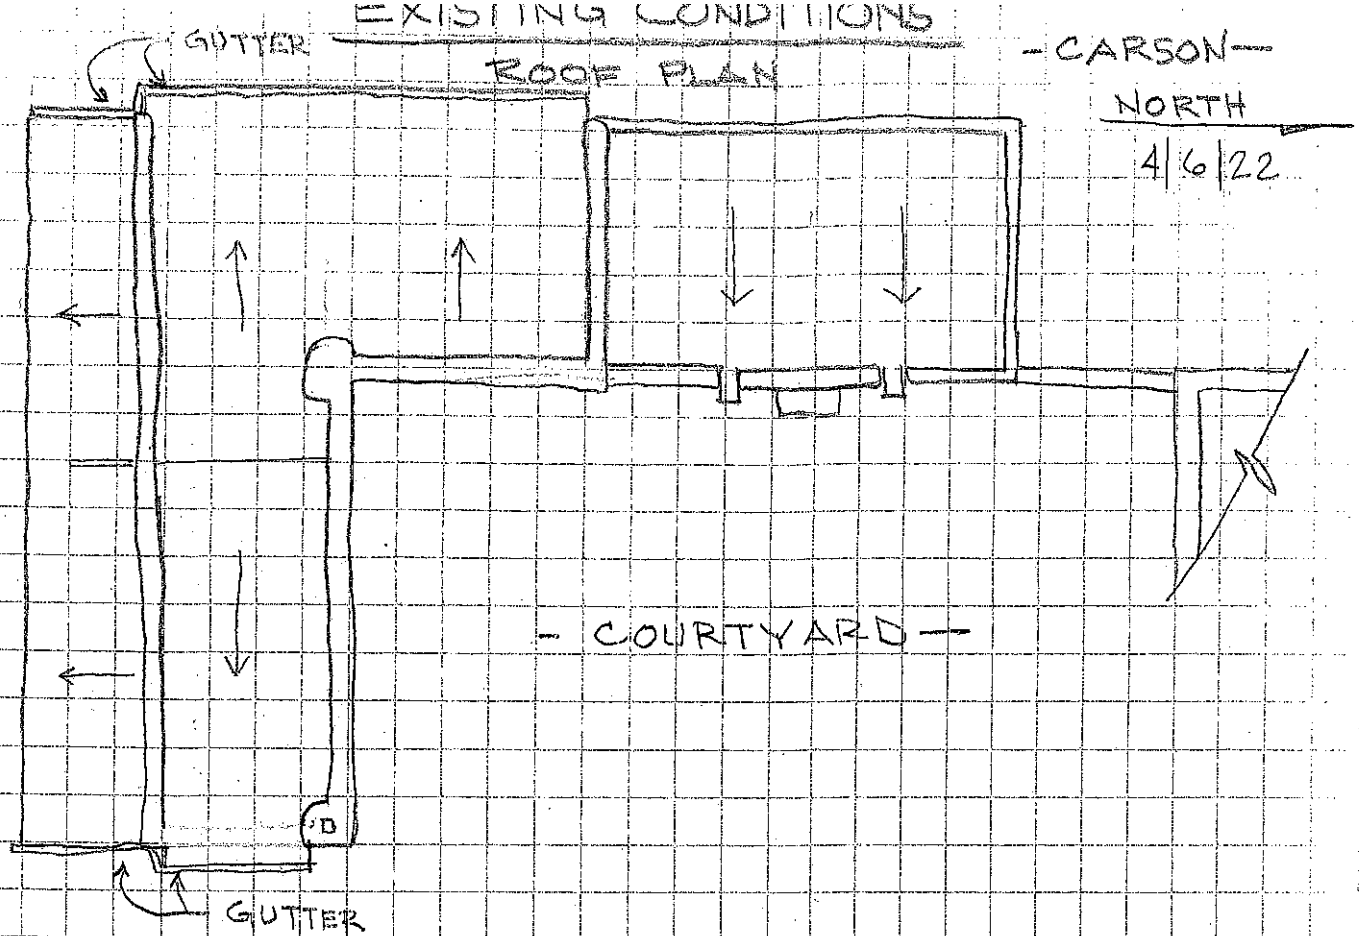
- CARSON HOUSE RMS1-4 SLOPE E/W WITH GUTTERS IN POOR CONDITION. (ROOF SLOPE OVER STRUCTURE, C. 1912)
- ROOM 5 SLOPES TO COURTYARD (EAST)
- APPEARS TO BE AT LEAST 2 LAYERS OF BUILT-UP ROOF. 90# MINERAL CAP SHEET. TOP LAYER ROOF REPORTED TO BE ± 27 YEARS OLD.
- PORTAL DRAINS TO STREET.
- ROOFING & GUTTERS PAST SERVICEABLE LIFE & NEED TO BE REMOVED & REPLACED.
- ORIGINAL DIRT ROOF REPORTED TO REMAIN.
- MINIMAL INSULATION IF ANY
- ROOFING CORES NEEDED FOR VERIFICATION

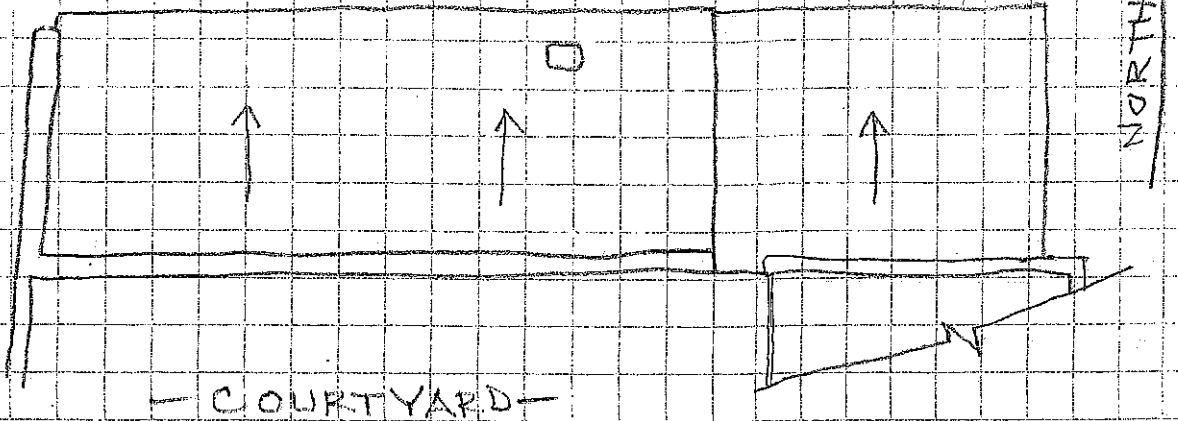
- ROOF SLOPES TO NORTH ONTO ADJ. PROPERTY
- GUTTERS NO LONGER IN PLACE
- REPORTED TO BE AT LEAST 2 LAYERS OF BUILT-UP ROOF. 90# MINERAL CAP SHEET. TOP LAYER ROOF VARIES IN AGE & CONDITION.
- ROOFING APPEARS TO BE IN FAIR CONDITION TO POOR CONDITION.
- ROOF SLOPE CREATED WITH DIMENSIONAL LUMBER OVER THE ORIGINAL ROOF (VIGAS)
- ORIGINAL DIRT ROOF REMAINS IN REMNANTS.
- GUTTERS SHOULD BE REPLACED.
- MINIMAL INSULATION IF ANY.
- ROOFING CORES NEEDED FOR VERIFICATION
- DIRT REPORTED REMOVED & REROOFED C. 2005 (R2-R4) PER MARTIN JAGERS 6/2/2022 EMAIL
- ROOF ABOVE R1 IS REPORTED TO BE ~35 YRS OLD AND IN POOR CONDITION.

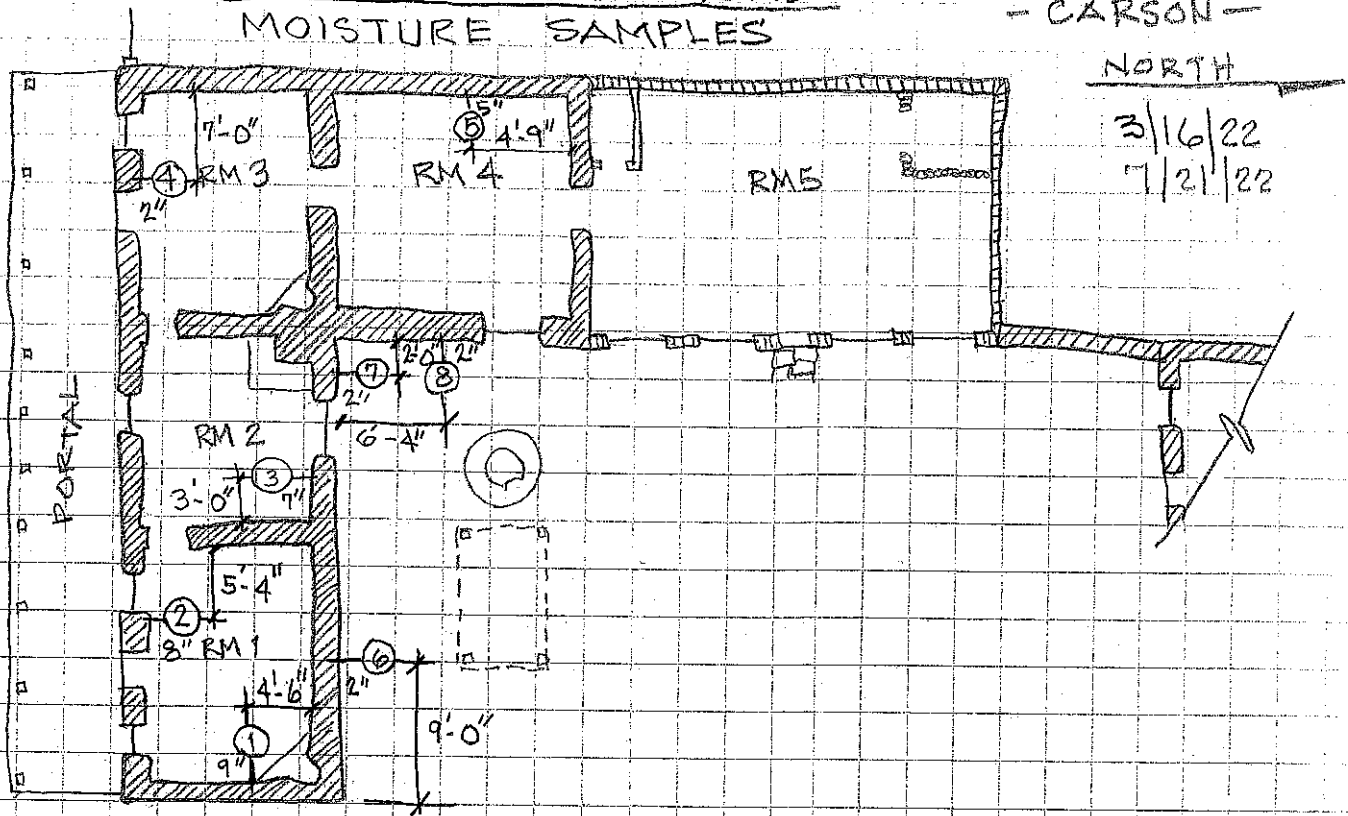
#1. WET WEIGHT 59 GRAMS
 DRY WEIGHT 57 GRAMS
 2 GRAMS
 $2/59 = .034 = 3.4\%$

WET WEIGHT 71 GRAMS
 DRY WEIGHT 68 GRAMS
 3 GRAMS
 $3/71 = .042 = 4.2\%$

2. WET WEIGHT 61 GRAMS
DRY WEIGHT 60 GRAMS
1 GRAM
 $1/61 = .016 = 1.6\%$

3. WET WEIGHT 52 GRAMS
DRY WEIGHT 49 GRAMS
3 GRAMS
 $3/52 = .058 = 5.8\%$

4. WET WEIGHT 55 GRAMS
DRY WEIGHT 51 GRAMS
4 GRAMS
 $4/55 = .073 = 7.3\%$

6. WET WEIGHT 61 GRAMS
DRY WEIGHT 57 GRAMS
4 GRAMS
 $4/61 = .066 = 6.6\%$

7. WET WEIGHT 60 GRAMS
DRY WEIGHT 53 GRAMS
7 GRAMS
 $7/60 = .117 = 11.7\%$

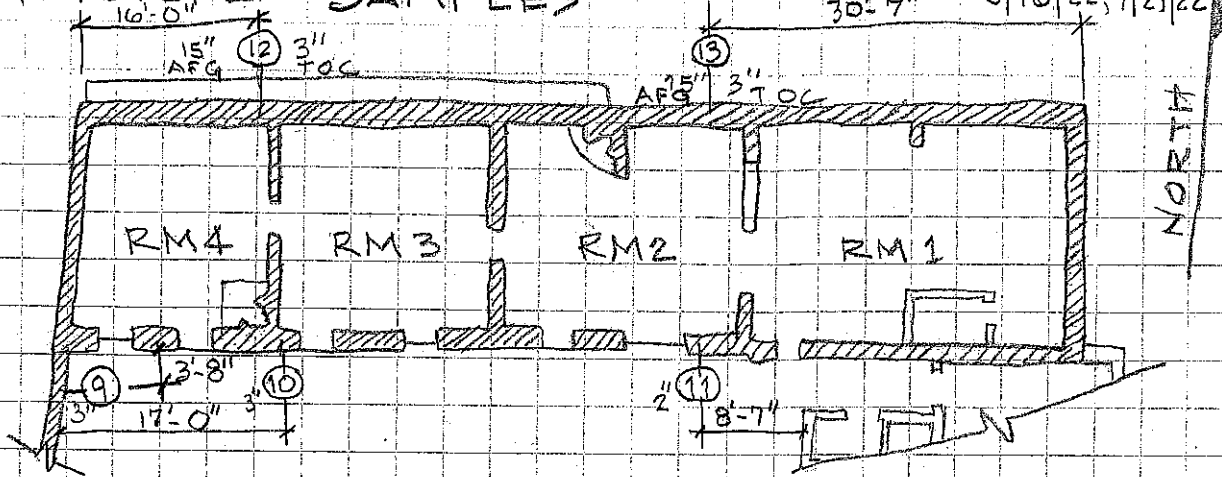
#9, WET WEIGHT	45 GRAMS
(±6") DRY WEIGHT	43 GRAMS
	2 GRAMS
$2/45 = .044 = 4.4\%$

#10, WET WEIGHT	64 GRAMS
DRY WEIGHT	62 GRAMS
	2 GRAMS
$2/64 = .031 = 3.1\%$

11. WET WEIGHT 34 GRAMS
(±6") DRY WEIGHT 31 GRAMS
3 GRAMS
 $3/34 = .088 = 8.8\%$

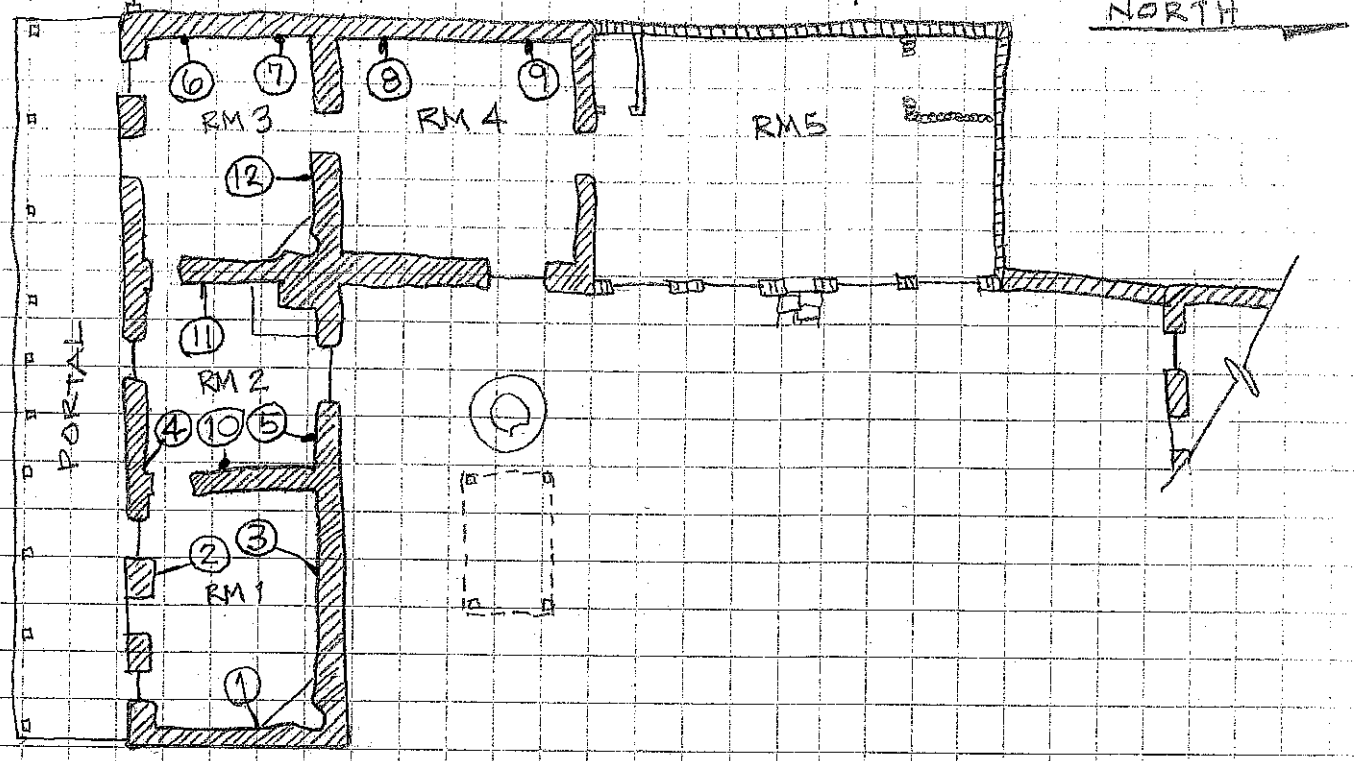
NO.	READING	LOCATION
1.	54	RM1 @ CLG. RIGHT OF FIREPLACE
	72	@ MID HGT.
	100	@ BTM.
	53	@ WD. BASE
2.	67	RM1 @ CLG SOUTH WALL
	75	@ MID HGT.
	80	@ BTM.
	13	@ WD. BASE
3.	74	RM 1 @ CLG NORTH WALL
	80	@ MID HGT.
	13	@ WD. BASE (PLASTER NOT ACCESSIBLE)
4.	64	RM2 @ CLG. SOUTH WALL
	70	@ MID HGT.
	100	@ BTM.
	16	@ WD. BASE

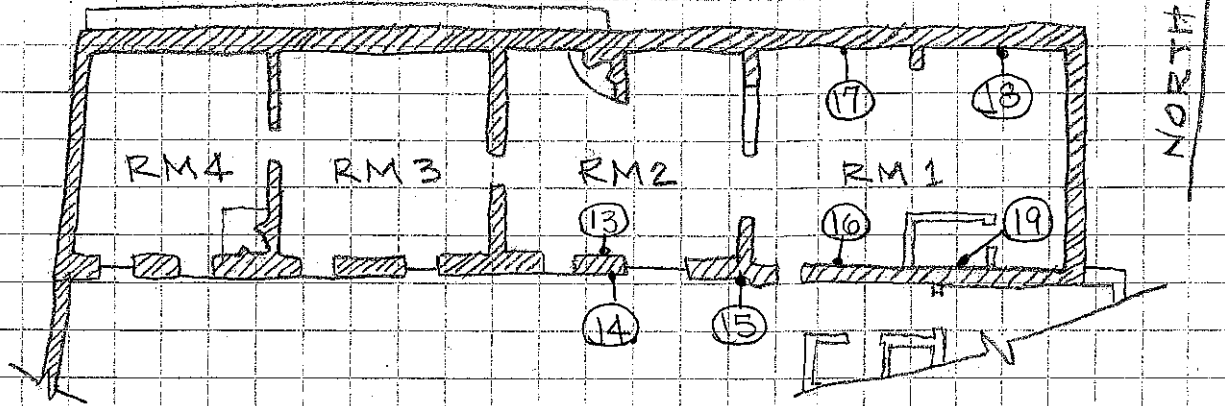
ROOMS 3 & 4 NOT ACCESSIBLE

NO.	READING	LOCATION
13.	100	RM 2 @ CLG. SOUTH WALL
	100	@ MID HGT.
	100	@ BTM. (NO WD. BASE)
14.	62	RM 2 @ BTM. OF STUCCO AT PARAPET (ADOBE)
	54	@ MID HGT.
	100	@ BTM.
15.	63	RM 2 @ BTM. OF STUCCO AT PARAPET (ADOBE)
	60	@ MID HGT.
	100	@ BTM.
16.	100	RM 1 @ CLG. SOUTH WALL
	100	@ MID HGT.
	100	@ BTM.
	18	@ WD. BASE
17.	100	RM 1 @ CLG. NORTH WALL
	100	@ MID HGT.
	100	@ BTM.
	53	@ WD. BASE

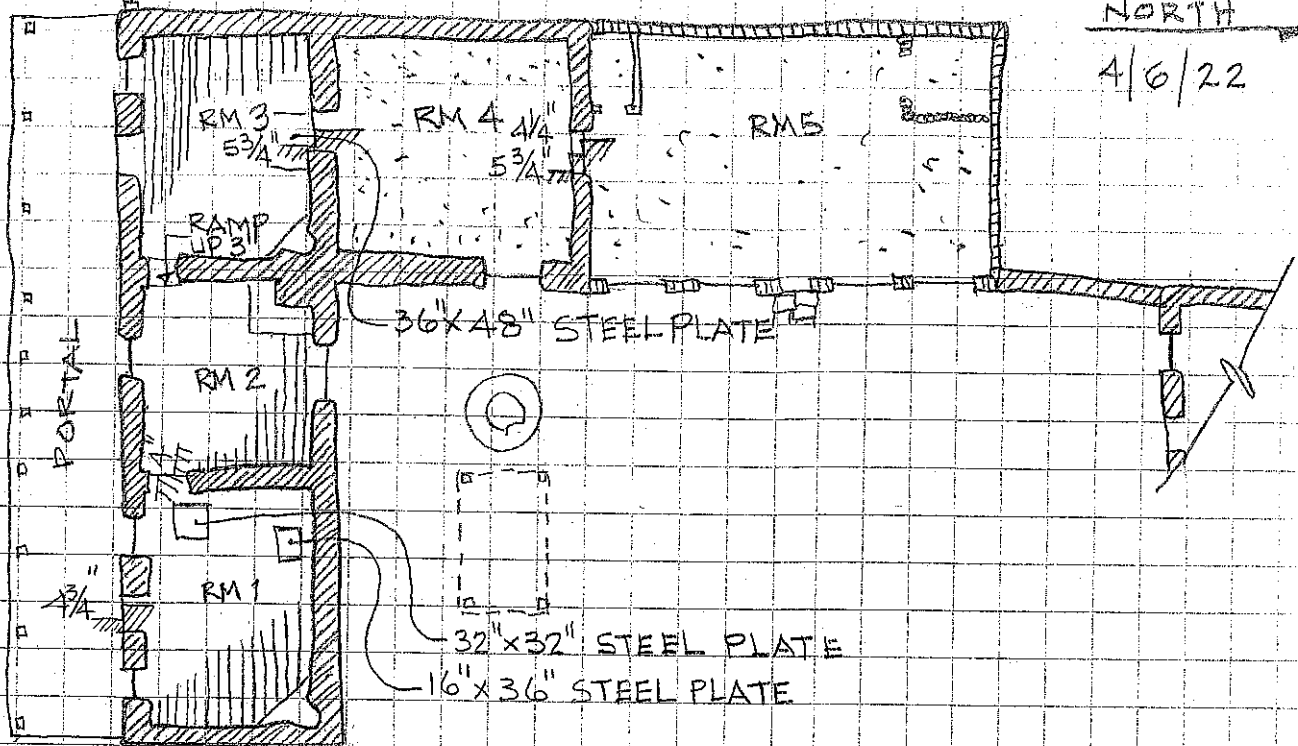
- ALL WOOD FLOORS APPEAR TO BE ON WOOD JOISTS AT OR NEAR THE GROUND. NO VENTILATION.
- CONC. SLABS ON GRADE.
- ROOM 1 - 3 1/4" T&G, FIR(?) UNFINISHED, SOFT SPOTS, E/W (ATTRIBUTED TO 1950s)
- ROOM 2 - 5 1/2" T&G, FIR(?) UNFINISHED, SOFT SPOTS, E/W (ATTRIBUTED TO 1927)
- ROOM 3 - 3 1/4" T&G, FIR(?) S ± 1/3, 5 1/2" T&G, FIR(?) N ± 2/3, FINISH WORN OFF, SOFT SPOTS, E/W (5 1/2" ATTRIBUTED TO 1927) ± 2'x2' SECTIONS CUT OUT & PATCHED AT SHORING VERTICAL MEMBERS.
- ROOM 4 - CONC. SLAB, APPEARS TO BE IN GOOD CONDITION, WITH CARPET. 9" SQ. VA TILE UNDER CARPET (SUSPECTED 1952)
- ROOM 5 - CONC. SLAB, APPEARS TO BE IN GOOD CONDITION, WITH CARPET. 9" SQ. VA TILE UNDER CARPET (1952)

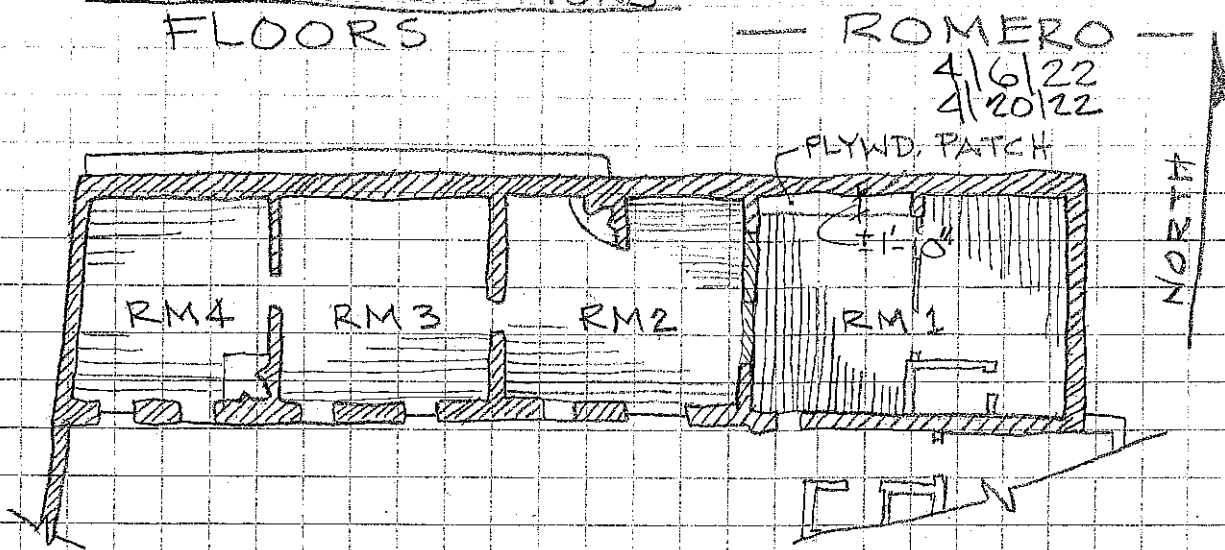
- WOOD FLOORS THROUGHOUT REPORTED TO BE ON WOOD JOISTS AT OR NEAR THE GROUND
- ROOM 1. - 5 1/2" T&G, PINE/FIR, STAINED, N/S, 2x6 RS JOISTS @ ± 2'-0" C/C
- ROOM 2. - RANDOM 3 1/2", 5 1/2", & 7 1/2" PLANKS, SOFT SPOTS, UNFINISHED, E/W, PINE/FIR
- ROOM 3 - 5 1/2" T&G, FIR, UNFINISHED, SOFT SPOTS, E/W
- ROOM 4 - FLOOR & STRUCTURE REPLACED C. 1998. 7 1/2" PLANKS ON 6x6 TREATED SLEEPERS ON THE GROUND, UNFINISHED, PINE(?), E/W
- VERY LIMITED ACCESS TO ALL ROOMS IN THE ROMERO HOUSE. ADD'L. REVIEW REQ'D.
- FLOORS APPEAR TO HAVE SETTLED IN RELATIONSHIP TO BASEBOARD.
- CRAWL SPACE AT LEAST IN AREA OF RM 1 RESTROOM ± 15" FROM FF TO DIRT.

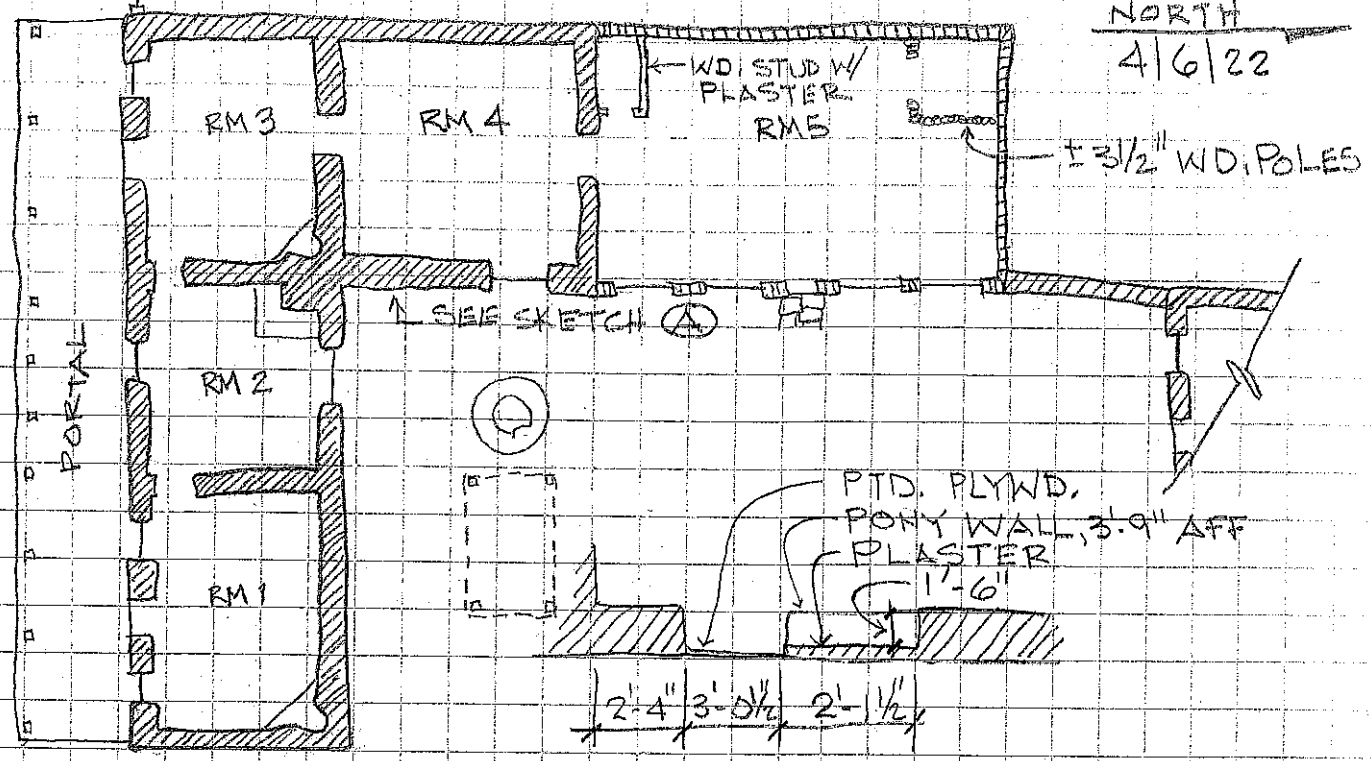
SKETCH (A)

- ALL WALLS ROOMS 1-4 ARE ADOBE APPROX. 20" THICK EXCEPT FOR INT. WALL BETWEEN RM1 & RM2 IS 11".
- ROOM 5 (1952) IS APPROX. 9" THICK AND BELIEVED TO BE CMU.
- EAST WALL AT SE CORNER NEAR FORMER DOOR APPEARS TO HAVE SOME CMU (ROOM 4)
- APPROX. NORTH 1/3 OF WEST WALL ROOM 4 WAS RECONSTRUCTED AFTER COLLAPSE C. 2019.
- BASE OF NORTH WALLS ROOMS 1 & 2 ARE BELOW FINISH EXTERIOR GRADE.
- BASE OF EAST WALL ROOM 3 IS BELOW FINISH EXTERIOR GRADE.
- ACCESS NEEDED TO REVIEW WEST WALL
- MOISTURE OBSERVED IN WALLS; DAMAGE TO BASE OF WALLS OBSERVED DUE TO WET/DRY CYCLE, FREEZE/THAW CYCLE AND CAPILLARY RISE. WATER PENETRATION AT PARAPETS PRESENT. MOISTURE STAINS OBSERVED AT

AT UPPER 1/3 OF ROOM 3 WEST WALL.

- ROOM 2 - WALL FINISH APPEARS TO BE ADOBE → ADOBE MUD PLASTER → TIERRA BLANCA CLAY RENDERING → PAINT. FINISH IS IN POOR CONDITION.
- ROOM 3 - WALL FINISH APPEARS TO BE ADOBE → ADOBE MUD PLASTER → LIGHT BLUE MICACIOUS CLAY WASH. FINISH IS IN FAIR CONDITION. SOME AREAS NEED REPAIR. MOISTURE STAINS ON WEST WALL.

- FIREPLACE IN ROOM 3 HAS MUD PLASTER AS FINISH COAT.
- EXTERIOR FINISH IS A COMBINATION OF MUD PLASTER AND CEMENT STUCCO ALL IN POOR CONDITION.
- SEVERAL LAYERS OF PAINT PRESENT IN AREAS ON INTERIOR WALLS. YELLOW WITH WHITE OVER IT.

- HISTORIC FINISHES SHOULD REMAIN IN PLACE. TEST REMOVAL OF PAINT & REPAIR/REAPPLY FINISHES CONSISTANT WITH HISTORIC.

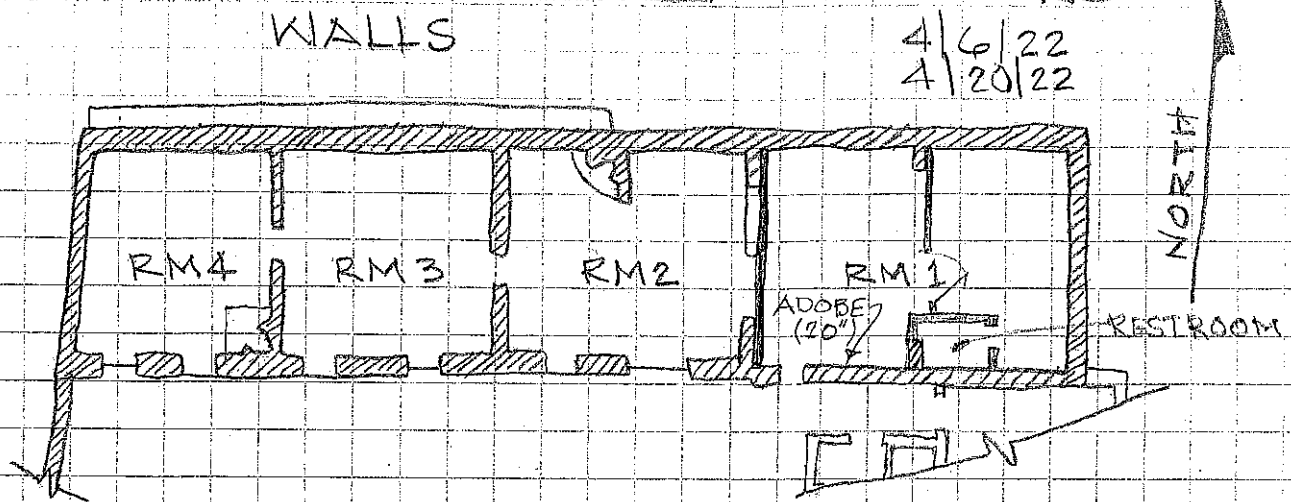
- ROOM 1 EAST AND SOUTH WALLS ARE CMU W/ CEMENT STUCCO EXT. FINISH IN FAIR CONDITION. NORTH WALL IS ADOBE WITH MUD PLASTER EXT. FINISH IN POOR CONDITION.
- ROOMS 2-4 EXT. WALLS ARE \pm 20" THICK ADOBE WALLS WITH MUD PLASTER FINISH IN POOR CONDITION.
- BASE OF NORTH WALL HAS A CONG. CONTRA PARED AND IS BELOW FINISH GRADE.
- BASE OF ADOBE WALLS EXHIBIT EXTENSIVE DAMAGE DUE TO WET/DRY CYCLE, FREEZE/THAW CYCLE AND CAPILLARY RISE.
- ADDITIONAL ACCESS TO INTERIOR OF ROMERO HOUSE IS NEEDED.
- RESTROOM WALLS ARE 2x4 STUDS @ 16" o.c. WITH GYP. BD. ON EXT. FACE, NO FINISH ON INT.
- ROOM 1 INT. PARTITION IS 2x4 STUDS W/ GYP. BD. BOTH SIDES. (NON HISTORIC)
- ROOM 1 WEST WALL - 2x4 WOOD STUDS W/ T1-11 (10" o.c.) ON EAST FACE, NO FINISH ON WEST FACE (RM 2). (NON HISTORIC)
- \pm 5" WIDE SECTION OF ADOBE AT RM1 NORTH WALL IS EXPOSED.

- ROOM 1 - ADOBE WALL. FINISH APPEARS TO BE ADOBE → MUD PLASTER → PAINT. WD. STUD WALLS → PTD GYP. BD. (WEST WALL UNFINISHED T1-11) CMU → GYPSUM PLASTER → PAINT. ALL IN POOR CONDITION. THE ADOBE IS BADLY ERODE NEAR THE WASTE VENT PIPE IN THE RESTROOM POSSIBLY DUE TO A PLUMBING LEAK. 1x4 PTD. BASE. WALL ± 20" THICK AT ENTRY DOOR.
- ROOM 2 - ADOBE WALL. FINISH APPEARS TO BE ADOBE → MUD PLASTER. INFILL AT EAST WALL IS EXPOSED 2x4 STUDS W/ PLYWOOD ON RM 1 SIDE. BASE OF INT. OF SOUTH WALL DETERIATED.
- ROOM 3 - ADOBE WALL. FINISH APPEARS TO BE ADOBE → MUD PLASTER → PAINT. WEST WALL APPEARS TO BE WOOD STUDS @ 18" c/c WITH MUD INFILL → MUD PLASTER → PAINT. 5 1/2" PAINTED WOOD BASE.
- ROOM 4 - ADOBE WALL. FINISH APPEARS TO BE ADOBE → MUD FINISH. EAST WALL APPEARS TO BE WOOD STUDS @ 18" c/c WITH MUD INFILL → MUD PLASTER.

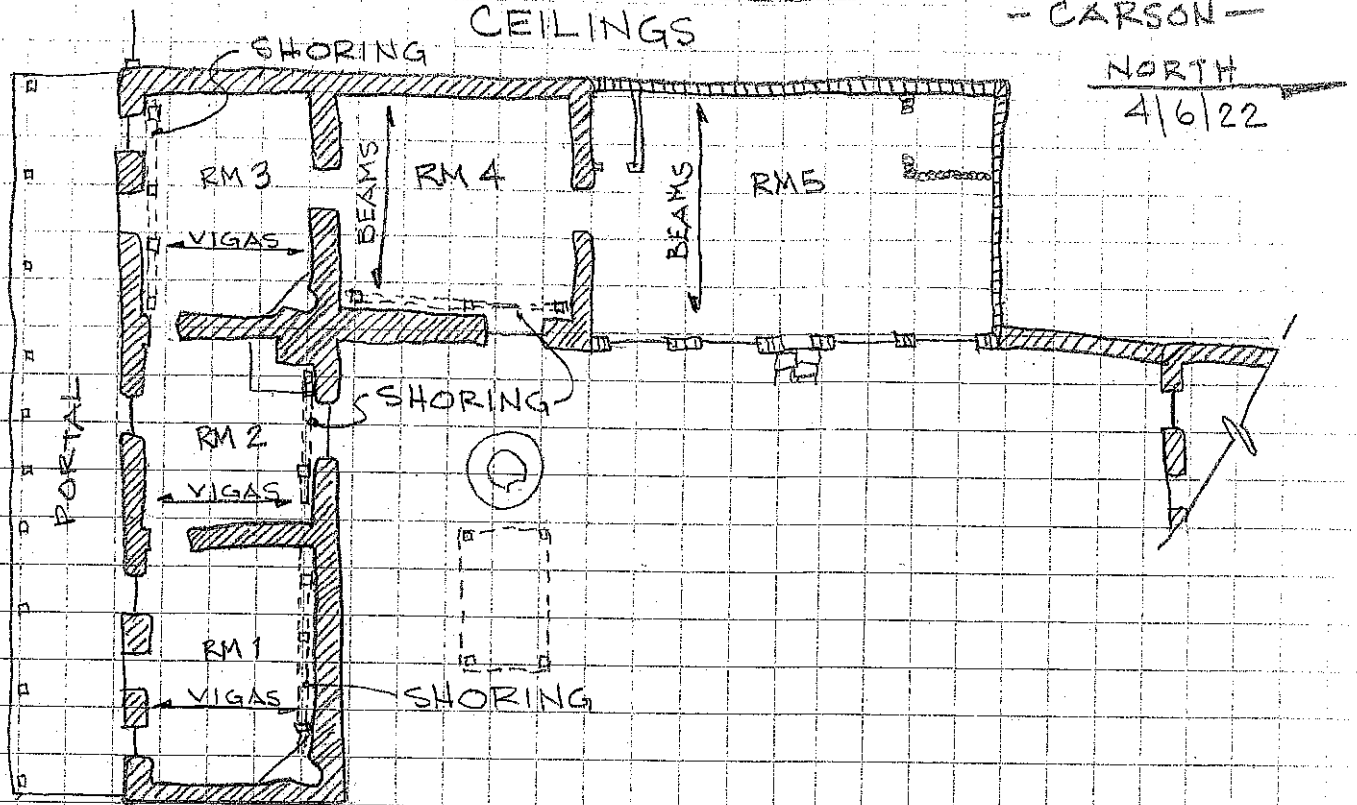
- ROOM 1 - (8) 6 1/2" to 10" ϕ VIGAS STAINED @ $\pm 28"$ C/C N/S
 7 1/4" STAINED BOARD CLG. E/W
 CLG. HGT. 9'-8 1/2" AFF @ SOUTH WALL CENTER
 9'-10 1/2" AFF @ NORTH WALL CENTER
 VIGAS SHORED ON NORTH END
- ROOM 2 - (5) 6 1/2" to 9 1/2" ϕ VIGAS STAINED @ $\pm 30"$ C/C N/S
 9" TO 12" STAINED BOARD CLG. E/W
 CLG. HGT. 10'-5" AFF @ SOUTH WALL CENTER
 10'-2 1/2" AFF @ NORTH WALL CENTER
 VIGAS SHORED ON NORTH END
- ROOM 3 - (7) 7 1/2" to 10 1/2" ϕ VIGAS STAINED @ $\pm 28"$ C/C N/S
 9 1/4" TO 11 1/4" STAINED BOARD CLG. E/W
 CLG. HGT. 10'-6" AFF @ SOUTH WALL CENTER
 10'-6" AFF @ NORTH WALL CENTER
 VIGAS SHORED ON SOUTH END

- ROOM 4 — (9) DOUBLE 2x8 JOISTS STAINED @ ± 28" C/C E/W
1x6"x" BRACING @ CENTER. 5 1/4" TO
7 1/4" STAINED BOARD CLG. N/S
CLG. HGT. 10'-4 1/2" AFF @ SOUTH WALL CENTER
10'-3" AFF @ NORTH WALL CENTER
BEAMS SHORED ON EAST END
- ROOM 5 — (17) 4x10 ADZED BMS STAINED @ ± 24" C/C E/W
3/4" STAINED BOARD CLG. N/S
CLG. HGT. 9'-2 1/2" AFF @ SOUTH WALL CENTER
9'-3" AFF @ NORTH WALL CENTER

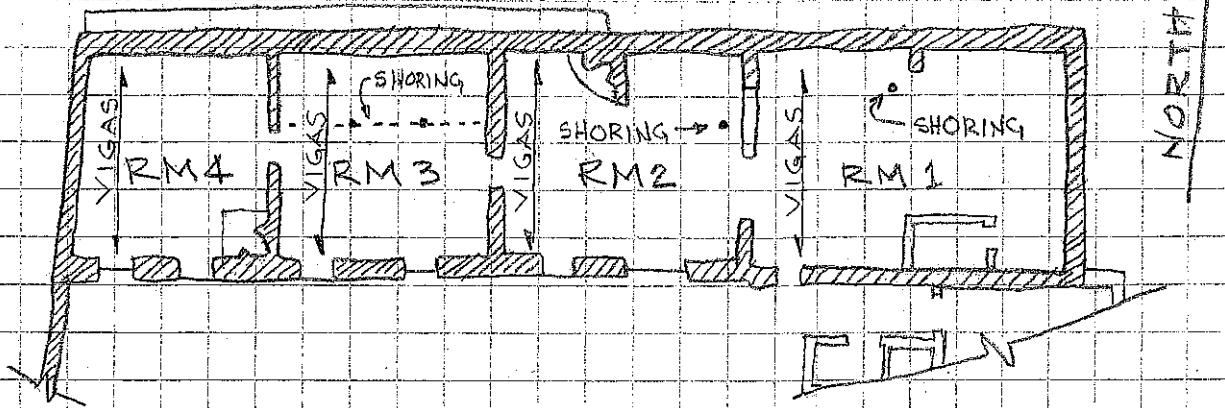
- ROOM 1 - (10) 7" TO 10" ϕ VIGAS STAINED @ $\pm 2'-6\frac{1}{2}"$ N/S
 $\pm 6"$ STAINED BOARD CLG. E/W
CLG. HGT. 8'-2" AFF @ SOUTH WALL CENTER
7'-9" AFF @ NORTH WALL CENTER
- ROOM 2 - (7) 8" TO 12" ϕ VIGAS STAINED @ $\pm 2'-6\frac{1}{2}"$ N/S
 $\pm 12"$ STAINED BOARD CLG. E/W POOR COND.
CLG. HGT. 8'-11" AFF @ SOUTH WALL CENTER
9'-3" AFF @ NORTH WALL CENTER
- ROOM 3 - (8) 7" TO 11 $\frac{1}{2}"$ ϕ VIGAS STAINED @ $\pm 2'-2\frac{1}{4}"$ N/S
 $\pm 12"$ STAINED BOARD CLG. E/W
CLG. HGT. 8'-11" AFF @ SOUTH WALL CENTER
8'-8" AFF @ NORTH WALL CENTER
- ROOM 4 - (7) 7" TO 10" ϕ VIGAS STAINED @ $\pm 2'-0"$ $\frac{1}{4}"$ N/S
10'-12" STAINED BOARD CLG. E/W
CLG. HGT. 9'-0" AFF @ SOUTH WALL
8'-11" AFF @ NORTH WALL
(2) 2x6 & 2x8 SISTER JOISTS @ 5 VIGAS
- ADDITIONAL ACCESS TO ROMERO HOUSE NEEDED

ROOM 1 - SINGLE POST @ 1ST VIGA WEST OF CENTER WALL

ROOM 2 - SINGLE POST @ 1ST VIGA WEST OF EAST WALL

ROOM 3 - TWO 4x6 POSTS W/ (3) 2x8 HORIZ.

ROOM 4 - TWO 6x6 POSTS W/ 8x12 FLAT HORIZ.
LOCATED 2'-6" E FROM NORTH WALL.

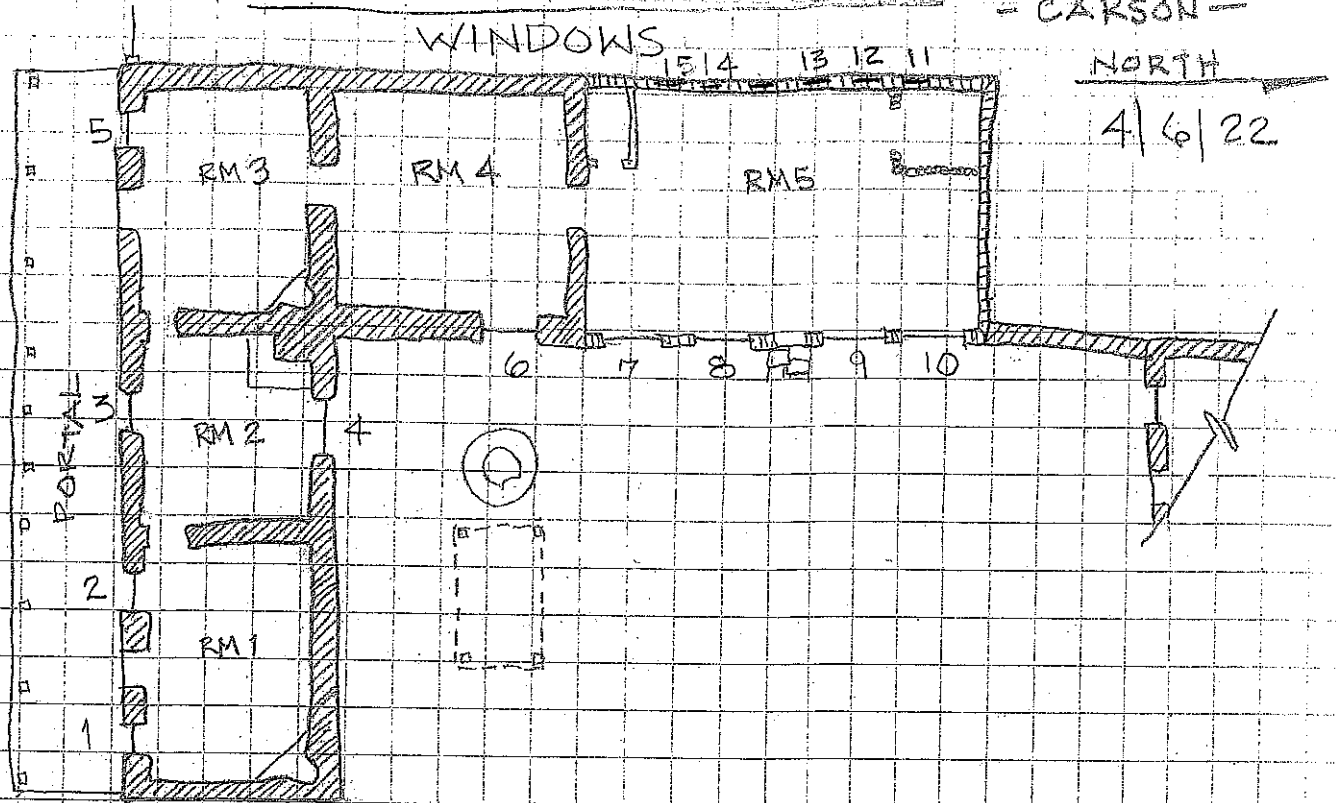
- WINDOWS APPEAR TO DATE FROM THE 1911 THROUGH 1950'S REMODEL. ALL WINDOW NEED REFURBISHING.
- WDW 1 - 2'-5" x 5'-6" 9 OVER 9 DOUBLE HUNG, PAINTED, 1x3 TRIM, 1911 SILL 1'-10 1/2" AFF
- WDW 2 - 2'-5" x 5'-6 1/2" 9 OVER 9 DOUBLE HUNG, PAINTED 1x3 TRIM, 1911 SILL 1'-9 1/2" AFF
- WDW 3 - 2'-5" x 3'-11" 6 OVER 6 DOUBLE HUNG, PAINTED, 1x3 TRIM, 1911 SILL 2'-4" AFF
- WDW 4 - PAIR 2'-0 1/2" x 5'-1 1/2" 4 OVER 4 DOUBLE HUNG, PAINTED, 1x3 TRIM, 1911? SILL 2'-9" AFF

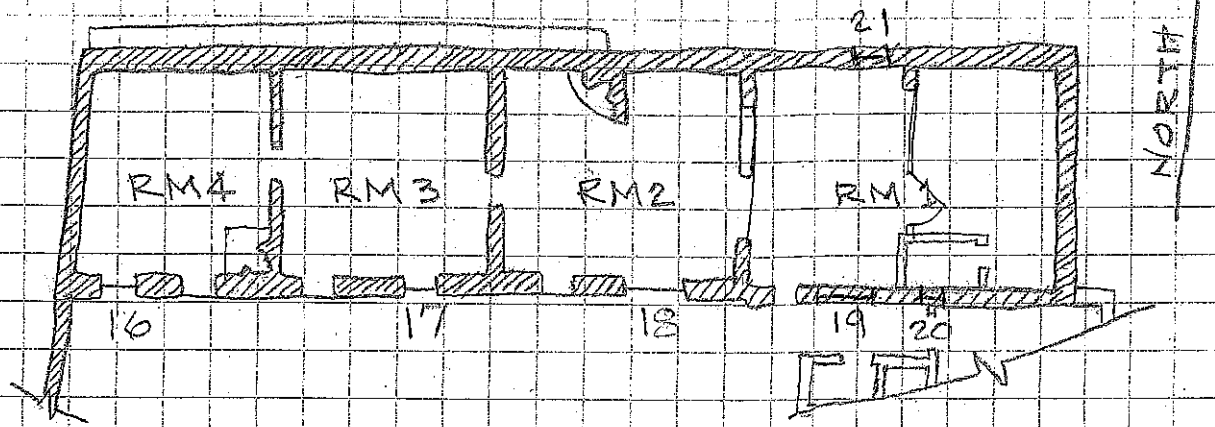
- WINDOW 16 — 2'-5½" x 5'-1" 2 OVER 2 DOUBLE HUNG, UNPAINTED, 1x4 UNFINISHED TRIM, WOOD SHUTTER, NOT PAINTED. WINDOW IS IN POOR CONDITION.
- WINDOW 17 — 2'-5" x 4'-5½" 2 OVER 2 DOUBLE HUNG, PAINTED, 1x4 PAINTED WOOD TRIM, WOOD SHUTTER, NOT PAINTED, WINDOW IS IN POOR CONDITION.
- WINDOW 18 — 3'-10" x 4'-7" WINDOW APPEARS TO HAVE BEEN REMOVED, PAINTED SHELVES INSIDE, 2'-5" x 2'-2" UNPAINTED WOOD SHUTTER ON OUTSIDE.
- WINDOW 19 — FORMER WINDOW LOCATION, NO ACCESS, WINDOW WAS LARGER THAN UNPAINTED WOOD SHUTTER ON THE OUTSIDE. INSIDE FRAME — 4'-5" x 4'-2½"
- WINDOW 20 — POSSIBLE FORMER WINDOW LOCATION
- WINDOW 21 — POSSIBLE FORMER WINDOW LOCATION AT BLOCKED GRILLE LOCATION.
