KIT CARSON HOUSE
Field Notes

KIT CARSON HOUSE & MUSEUM - RENOVATIONS
TAOS, NEW MEXICO

EXTERIOR ELEVATIONS - EXISTING
 KIT CARSON HOUSE & MUSEUM - CONDITION ASSESSMENT & PRESERVATION PLAN
 TAOS, NEW MEXICO

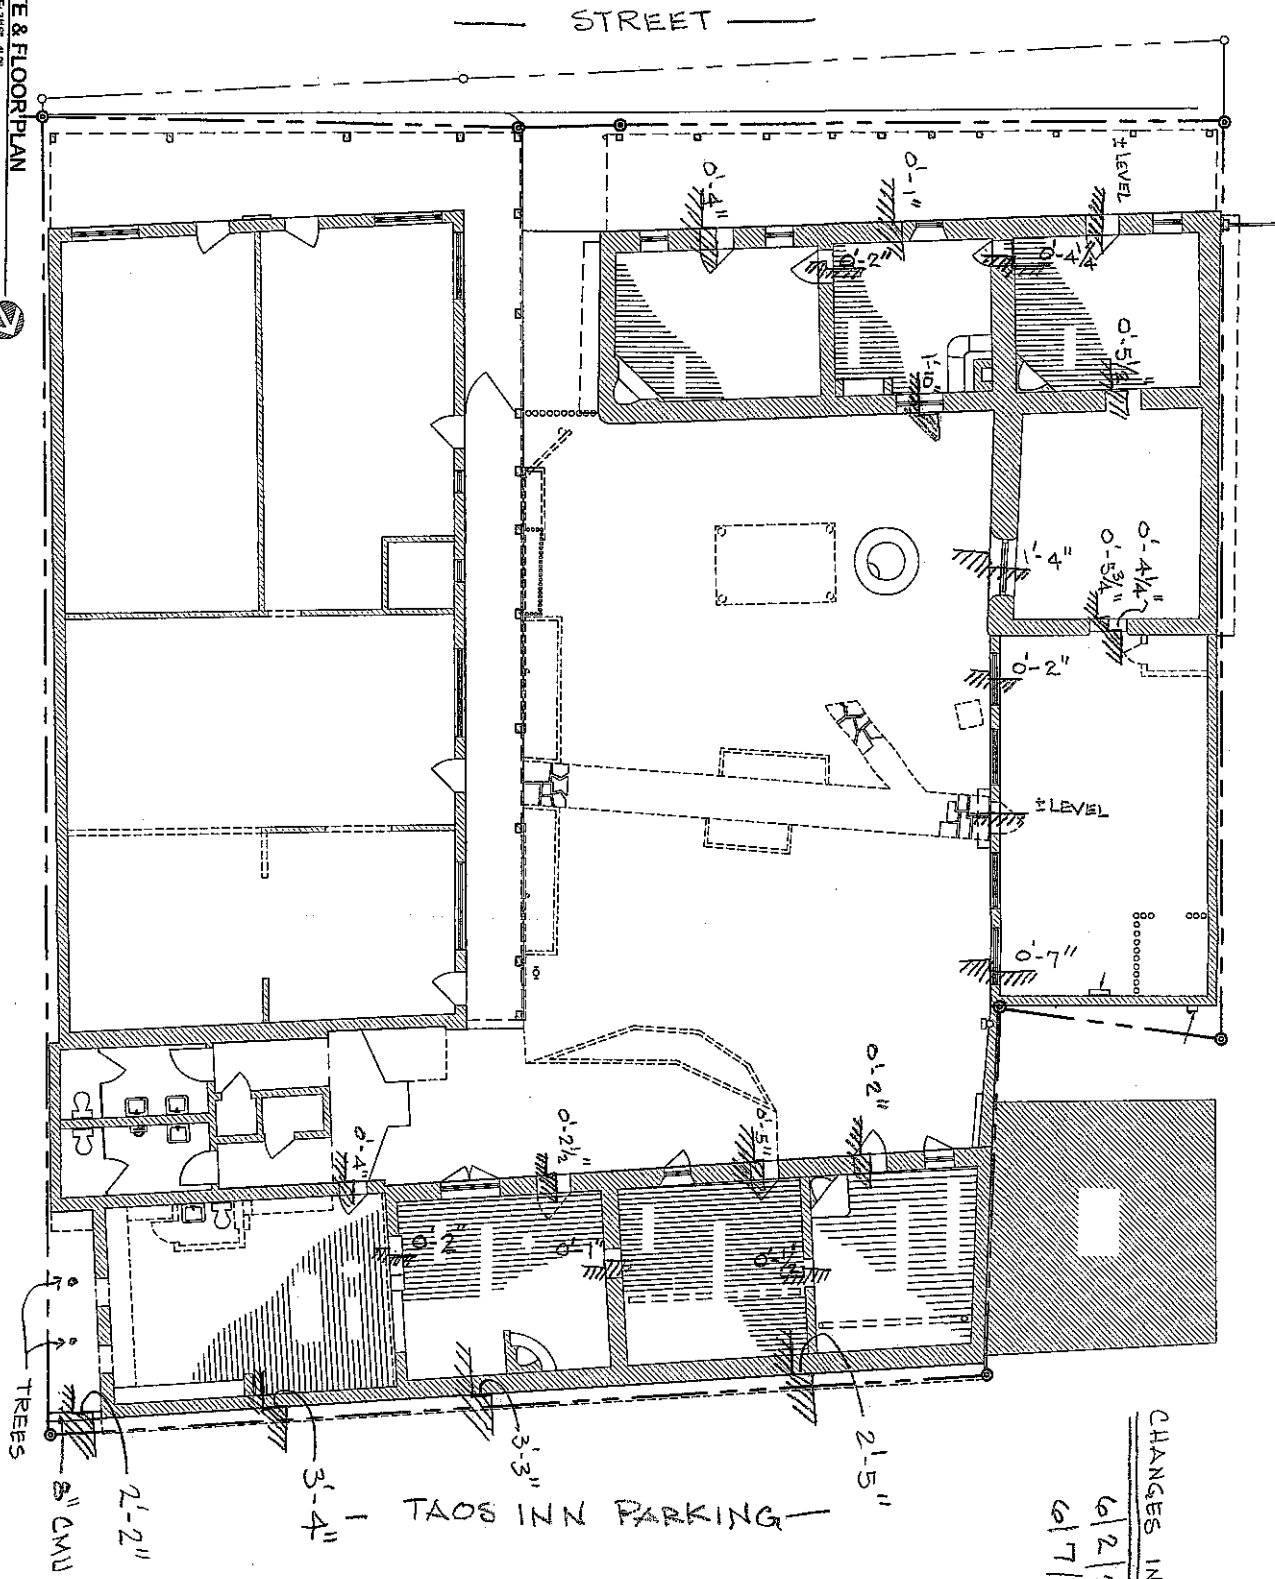
- AREAWAY DRAINAGE IS PROBLEMATIC. 1990'S RESTROOM ADDITION BLOCKS DRAINAGE.
- MET ALEX ABEYTA AT SITE 6/7/22 TO REVIEW DRAINAGE AND PROPOSED WORK.
- SEE CHANGES IN ELEVATION SITE PLAN, 6/2/22 AND 6/7/22.
- REPORTED INLET DRAIN IN AREAWAY IS NOT VISIBLE.
- BRIEF CONVERSATION WITH JOE KENDALL, GENERAL MANAGER TAOS INN ABOUT POSSIBILITY OF REGRADING PARKING LOT.

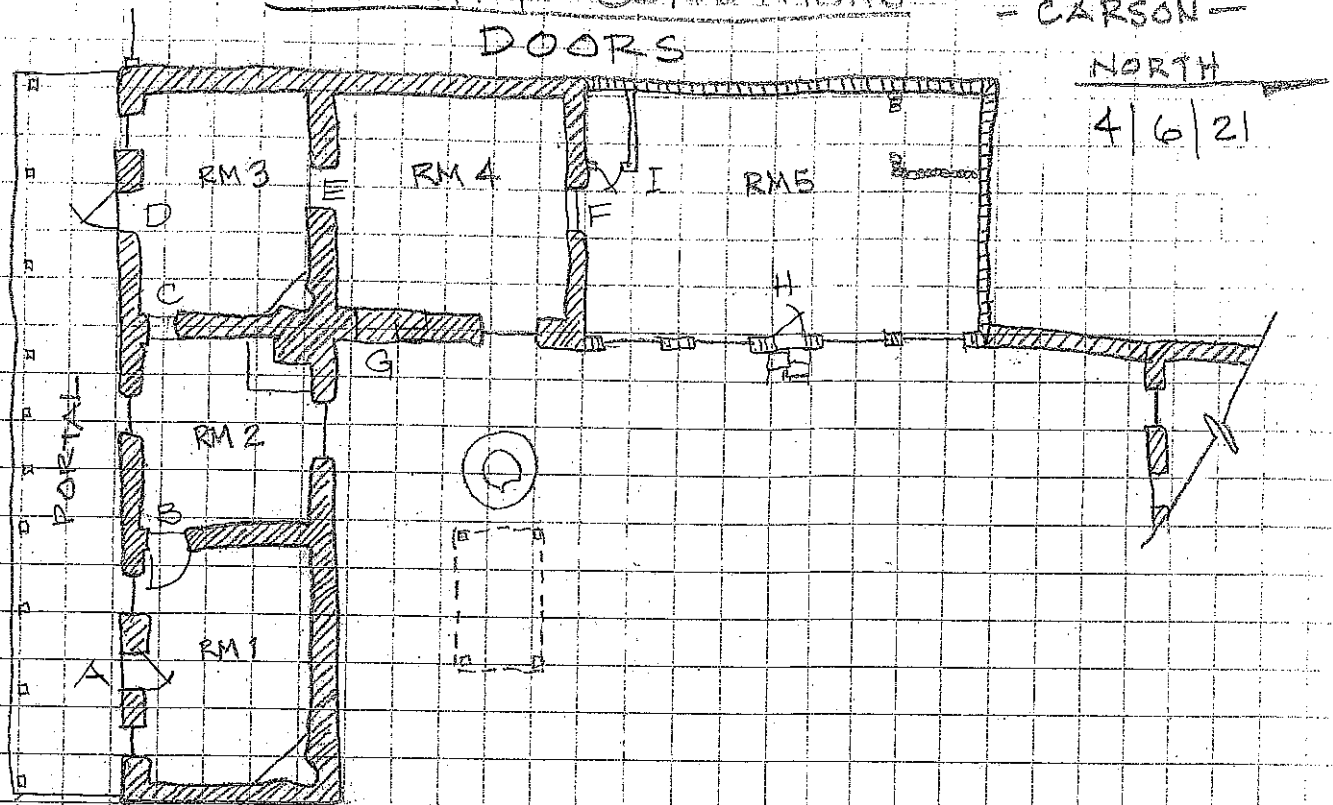
- THE DOORS APPEAR TO DATE MOSTLY FROM THE MID TO LATE 20TH CENTURY AND ARE GENERALLY SERVICEABLE
- DOOR A - 3'-0" x 6'-4³/₄" WOOD PLANK DOOR. PTD. INT., WOOD THRESHOLD, WOOD SCREEN DOOR, STAIN EXT., PAINTED TRIM C. 1940's (HSR)
- DOOR B - 2'-5⁵/₈" x 5'-10¹/₂" WOOD PLANK DOOR, PAINTED, WOOD THRESHOLD, PAINTED 1 x 3 WD. TRIM, 1912 OR OLDER (HSR)
- DOOR C - 2'-7" x 5'-8⁵/₈". NO DOOR, JAMB SIDE OF PINTLE HINGE PRESENT, PAINTED JAMB, WOOD THRESHOLD.
- DOOR D - 3'-0" x 6'-3¹/₂" WOOD PLANK DOOR. "EMERG. EXIT", PANIC HARDWARE WOOD JAMB & 1 x 6 TRIM W/ PAINT MOSTLY REMOVED. 6¹/₂" x 3'-0" TRANSOM, 11¹/₂" x 14" FIXED LIGHT AT 4'-8" AFF., MTL. THRESHOLD. C. 1940's (HSR)

- DOOR E - DOOR OPENING 2'-8" x 6'-6". NO DOOR. PAINTED WOOD JAMB, PAINTED WOOD THRESHOLD. DOOR OPENED INTO RM. 4 BASED ON HINGE LOCATION.
- DOOR F - DOOR OPENING 3'-3" x 7'-2" (ON RM. 5 SIDE) SLIGHTLY ARCHED TOP. NO DOOR. PAINTED PLASTER JAMB AND HEAD. 2 CONCRETE/CARPET STEPS DOWN INTO ROOM 4.
- DOOR G - 3'-1" x 6'-10", DOOR HAS BEEN SEALED UP WITH WHAT APPEARS TO BE PAINTED PLYWOOD.
- DOOR H - 2'-11½" x 6'-5" 3 PANEL WOOD DOOR WITH 2'-0" x 2'-3½" LIGHT. PAINTED. WOOD JAMB, CONCRETE THRESHOLD. CONTEMPORARY HARDWARE PASSAGE SET AND TWO DEAD BOLTS. SCREEN DOOR, STAINED, WOOD W/ 3 BOTTOM PANELS. NO TRIM.
- DOOR I - 1'-11½" x 6'-7" 2 PANEL PAINTED WOOD DOOR, CONTEMPORARY HARWARE, PAINTED WOOD JAMB, NO THRESHOLD, NO TRIM.

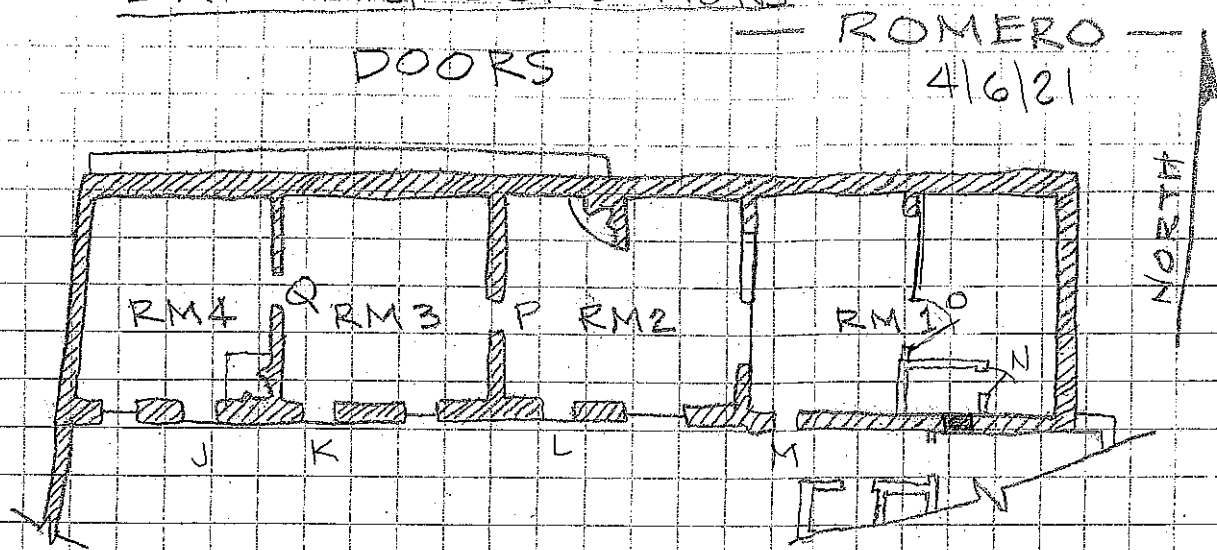
- ALL DOORS & HARDWARE APPEAR TO DATE FROM THE SECOND HALF OF THE 20TH CENTURY AND NEED WORK.
- DOOR J — 3'-0" x 6'-7½" WOOD PANEL (PLANKS) UNFINISHED. REPORTED TO BE A 1990'S REPLICA. MODERN HINGES, CONC. SILL, DEADBOLT.
- DOOR K — 2'-8" x 6'-5½" ½ LIGHT, 3 PANEL WOOD DOOR, PAINTED. 1x4 PAINTED TRIM. WOOD THRESHOLD. APPEARS TO HAVE HAD A METAL GRILLE (NO PAINT UNDER WHERE GRILLE ATTACHED TO DOOR) MODERN DEADBOLT. C. 1950'S
- DOOR L — 2'-7" x 6'-0" x 3½" HAND ADZED TWO PANEL STAINED WOOD REPLICA DOOR. 4¾" THICK HAND ADZED STAINED WOOD REPLICA JAMB (3½" INT). REPLICA HARDWARE. WOOD THRESHOLD. ± 1998 (HSR)

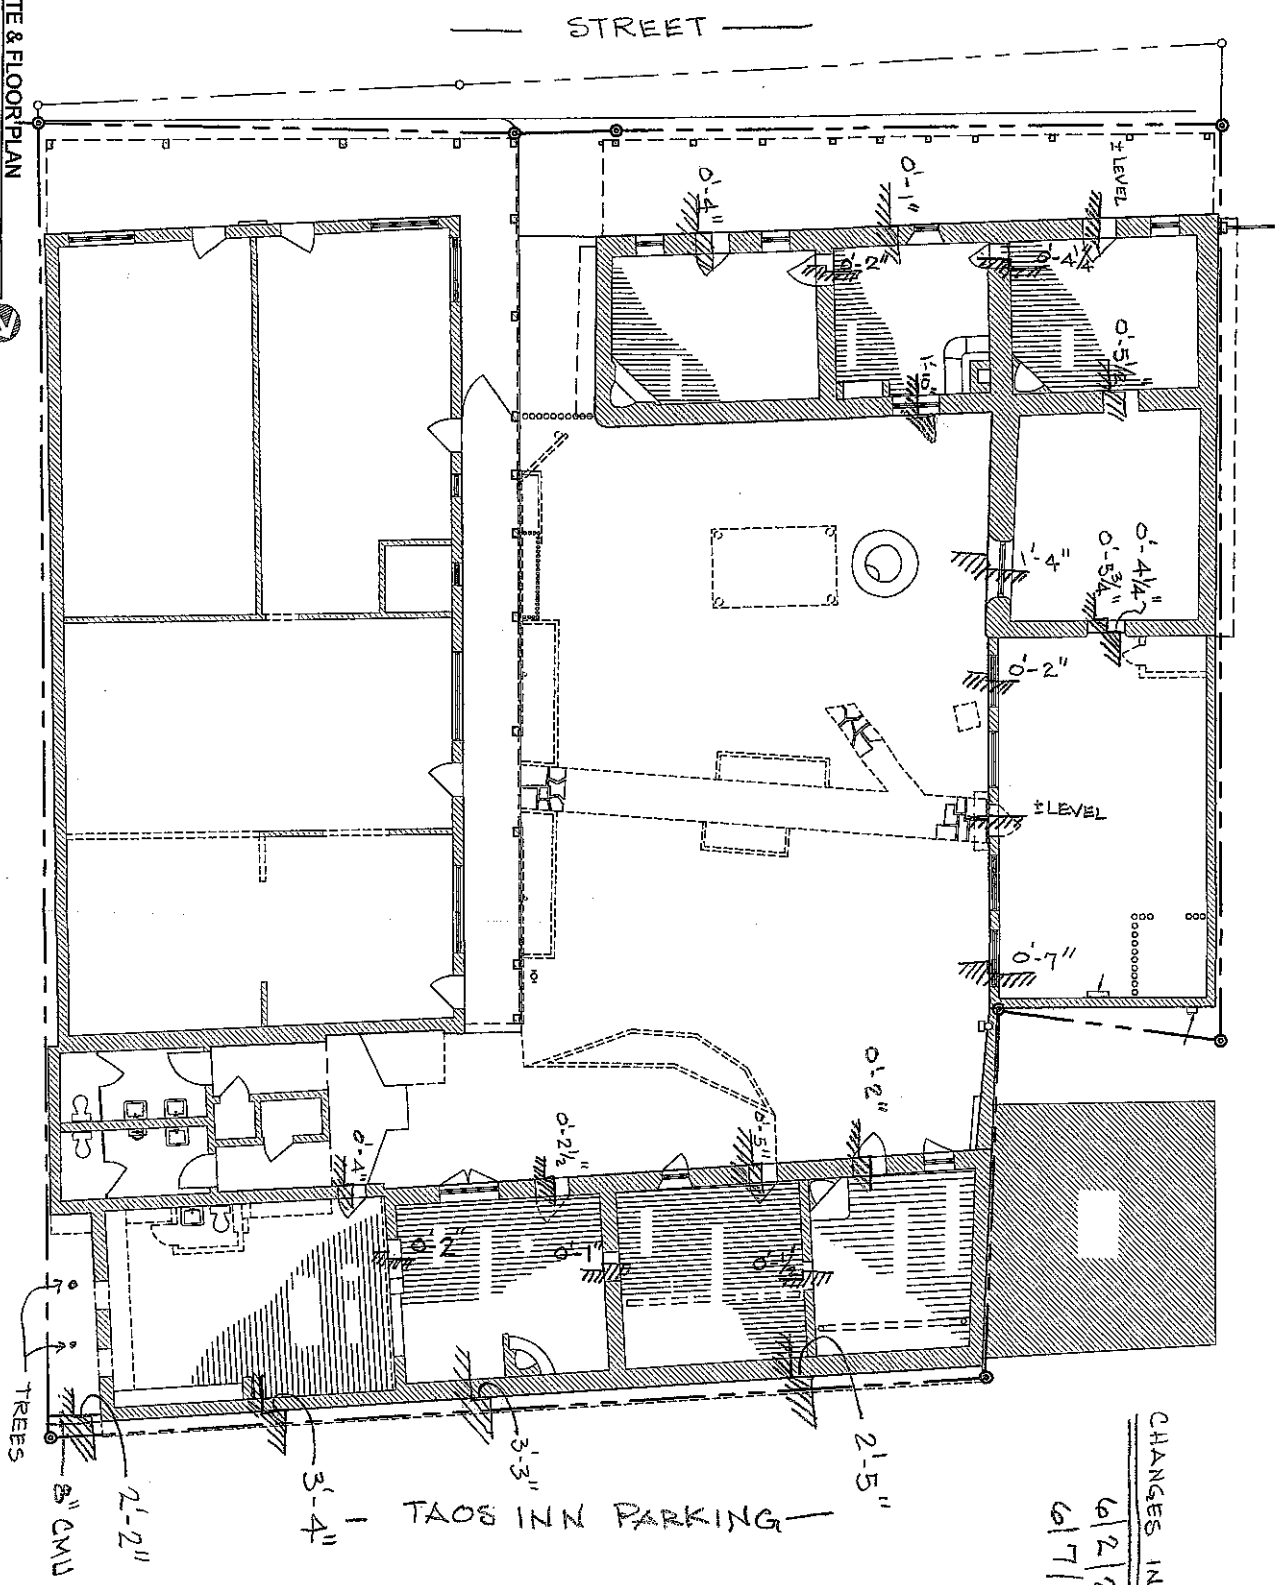
A1 SITE & FLOOR PLAN
SCALE: 3/8" = 1'-0"

- HISTORIC STRUCTURES ARE NOT ACCESSIBLE PER. CURRENT STANDARDS
- APPROX. 15 1/2" CHANGE IN FLOOR LEVELS IN CARSON HOUSE ROOMS 3-5
- APPROX. 6" CHANGE IN FLOOR LEVELS IN CARSON HOUSE ROOMS 1-3
- APPROX. 1 1/2" CHANGE IN FLOOR LEVELS IN ROMERO HOUSE.
- DOORS & HARDWARE NOT ACCESSIBLE
- CURB RAMP & SIDEWALK APPEARS TO NOT MEET CURRENT STANDARDS
- ABANDONED RESTROOM IN ROMERO HOUSE WAS NOT ACCESSIBLE. MUSEUM CURRENTLY USES TOWN CONSTRUCTED FACILITIES.
