TABLE OF CONTENTS

4. Carson Home Historic Portal Structure Report (separate document)

Karen Young, Director, Taos Historic Museums
Dale Zinn Historic Architect

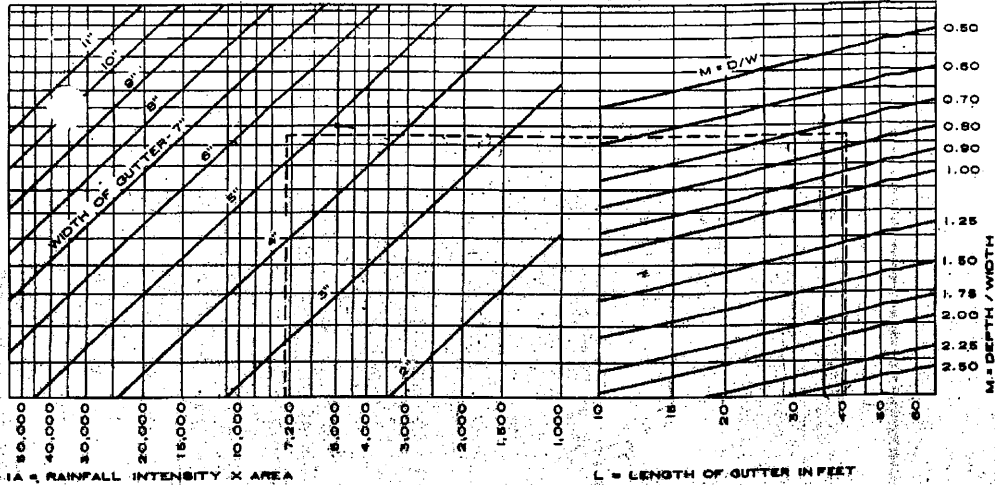
WIDTH OF RECTANGULAR GUTTERS FOR GIVEN ROOF AREAS AND RAINFALL INTENSITIES

NOTE:
The terms "leader," "conductor," and "downspout" all mean the same thing.

The most problematic element of the roof and drainage systems for the entire museum is the disposal of the water once it has left the roof. The gutter systems provided on the east and west sides of the Carson House are necessarily carried out to the south side of the building where the water can be disposed of in the public streets. Historic photos for the early 1920s show the various systems for supporting the drainage system were, at best, awkward. The calculations for the capacity of discharge of roof water was calculated using a standard for northern New Mexico of 5"/hour rainfall intensity for a period of 10 minutes. Discharge capacities of the gutter systems are shown on the roof plans attached to this report and a chart republished from the Architectural Graphic Standards (Ramsey and Sleeper) Sixth edition is included herein.

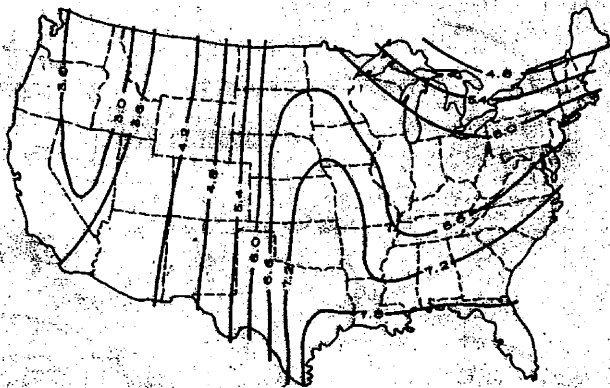
First size downspout from tables below. Then use gutter 1 inch larger in diameter.

RAINFALL INTENSITY MAP
